INSTALLATION INSTRUCTIONS

FRONT GRILLE TRIMS P/N 08F21-TLA-100B 2021 CR-V 2021 CR-V HYBRID

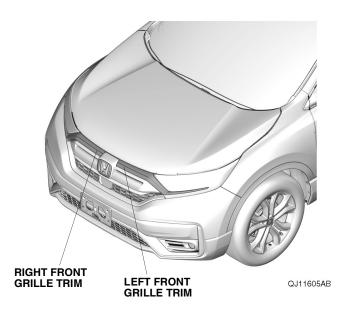
Illustration of the Front Grille Trims on the Vehicle

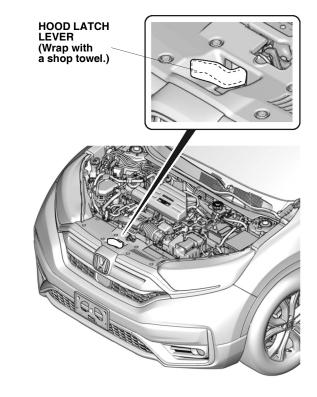
QHD2607AA

- 1. Disconnect the negative cable from the battery, then wait at least 3 minutes before starting work.
- 2. Wrap a shop towel around the hood latch lever.

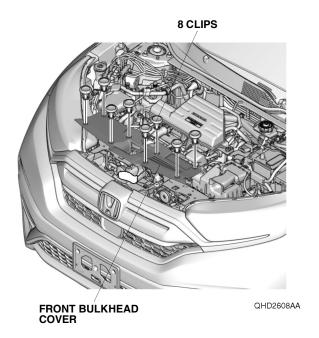
3. Remove the front bulkhead cover.

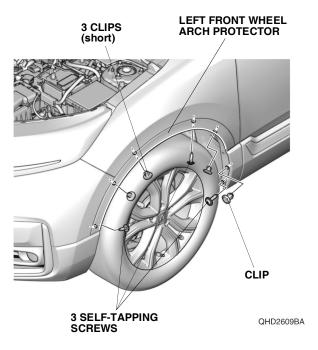
4. Remove the three self-tapping screws, one clip, and three clips (short) from the left front wheel arch protector as shown.

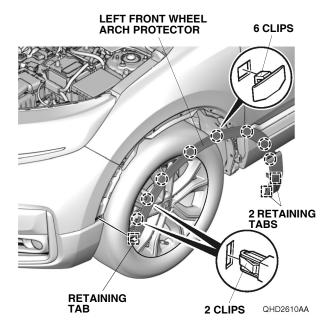
5. Remove the left front wheel arch protector as shown.

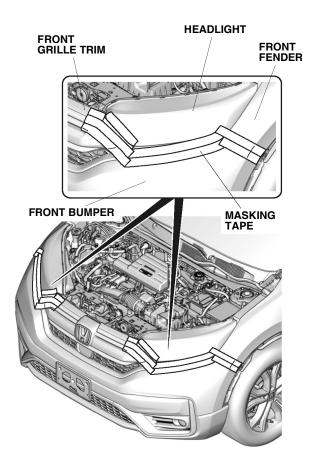
QJ20601AB

• Apply masking tape on each side as shown.

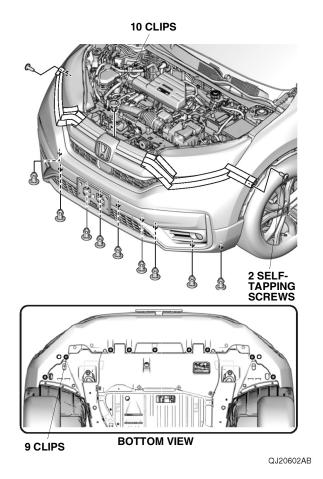
• Remove the two self-tapping screws and 10 clips as shown.

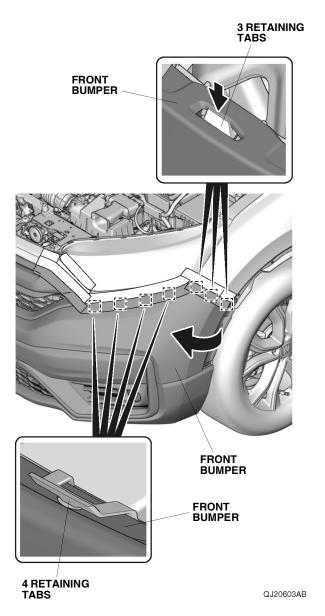
• With the help of an assistant, release the seven retaining tabs on each side.

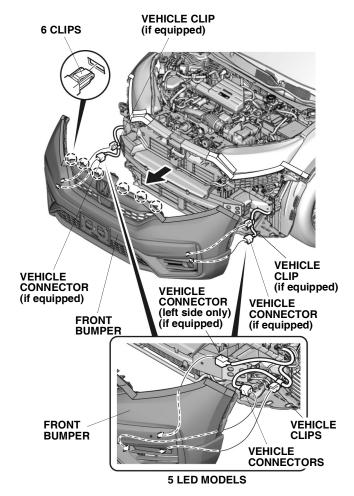
QJ52301BB

- With the help of an assistant, remove the front bumper, and unplug the vehicle connectors (if equipped).
- Place the front bumper on a blanket.

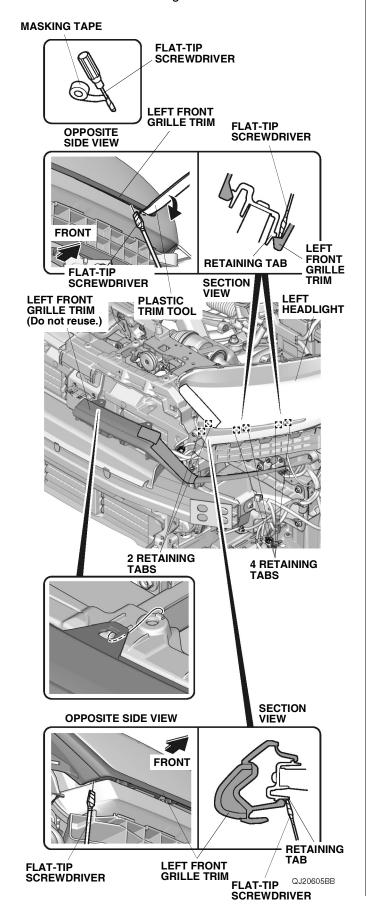
8. Remove the left front grille trim as shown.

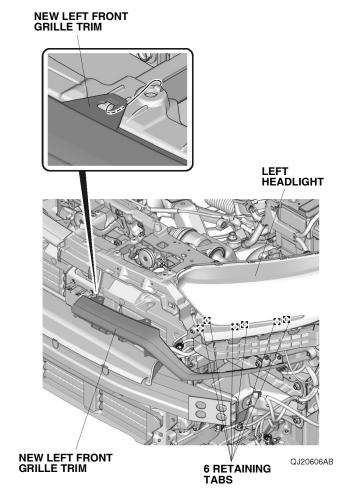
9. Install the new left front grille trim.
